Appendix I4

Biological Opinion & Biological Assessment

Consultation Number: 02ETAU00-2015-F-0031

RE: CSJs 0253-04-138 & 0253-04-146

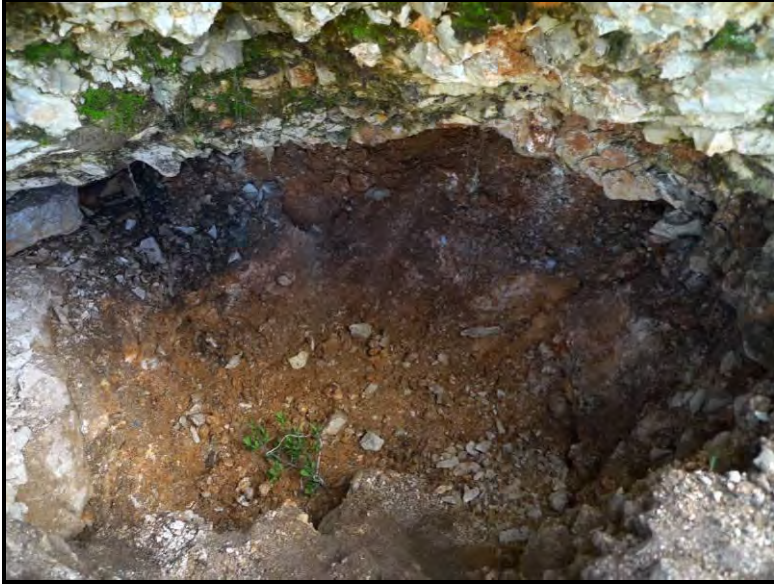
Figure 130. Interior of feature 281-075 after excavation.

281-075, solution cavity/enlarged bedding plane This feature is an enlarged bedding plane developed in the east road cut of US 281. When initially assessed it was 1 m (3.3 ft) wide, 0.4 m (1.3 ft) tall, and extended into the road cut for 1.5 m (4.9 ft) (Figure 129). It contained black, modern soil, rocks, and leaf litter. This feature receives channelized flow from the highway bar ditch. The troglophile meshweaver spider *Cicurina varians* was found in this feature. Excavation was conducted on 15 June 2010. Eight person hours of effort utilizing hand tools resulted in the removal of 1 m³ (35 ft³) of material. This resulted in the enlargement of the entrance to 1.5 m (4.9 ft) in diameter, and the floor was lowered to 1 m (3.3 ft) below the elevation of the bar ditch for a total depth of 2 m (6.6 ft). The floor was composed of clay that extended up the walls to meet the bedrock ceiling, with no voids visible (Figure 130).

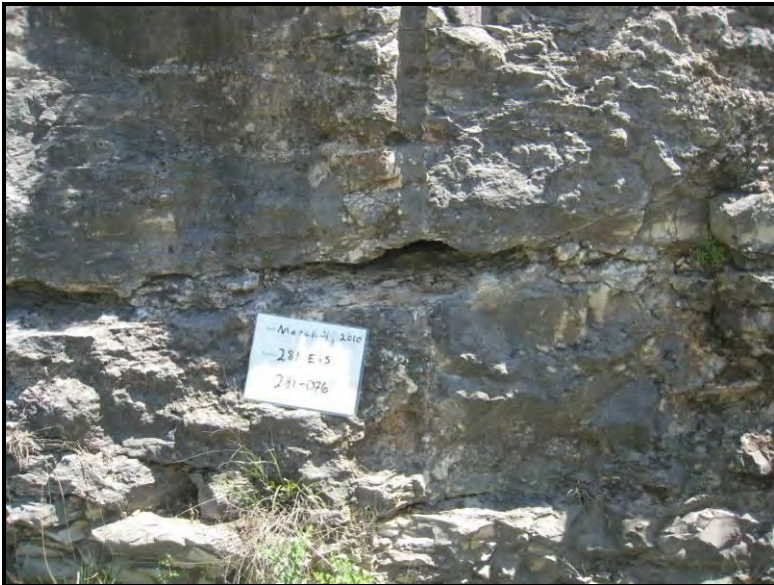
281-076, solution cavity/enlarged bedding plane This is an enlarged bedding plane in the east road cut of US 281. The entrance to the feature is 0.5 m (1.6 ft) wide and 0.3 m (1 ft) tall (Figure 131). It extends into the road cut for 1 m (3.3 ft). It contains no infill material (Figure 132). This feature was not recommended for excavation (Table 1).

Figure 131. Overview of feature 281-076.

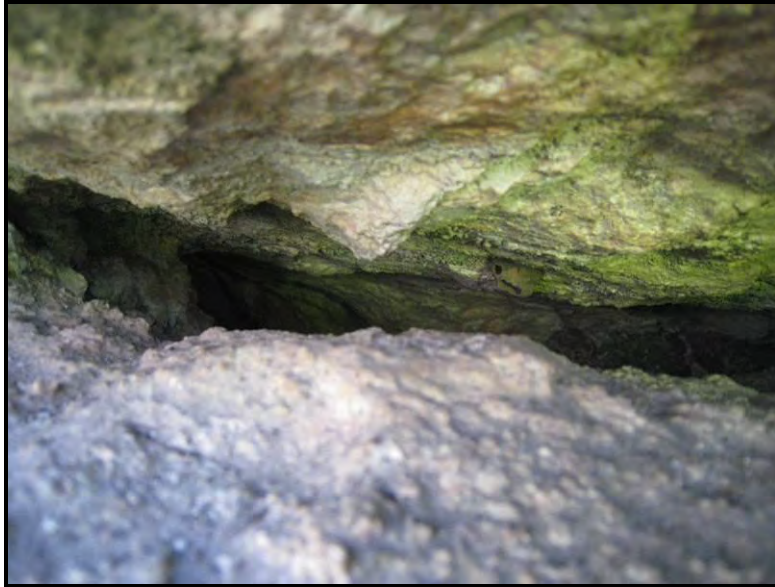
Figure 132. Interior of feature 281-076.

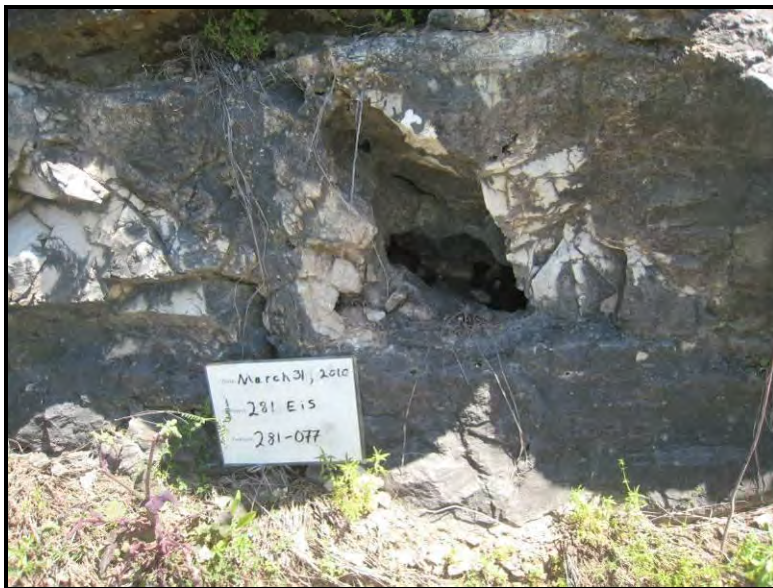
Figure 133. Overview of feature 281-077.

281-077, solution cavity/enlarged fracture This feature is an enlarged fracture trending at 150 degrees. It is situated in the east road cut of US 281 (Figure 133). The entrance is 0.25 m (0.8 ft) wide, 0.25 m (0.8 ft) tall, and it extends into the road cut for 0.4 m (1.3 ft). It has minor amounts of rock infill, and flowstone covering some surfaces (Figure 134). Gastropod shells were observed in this feature. This feature was not recommended for excavation (Table 1).

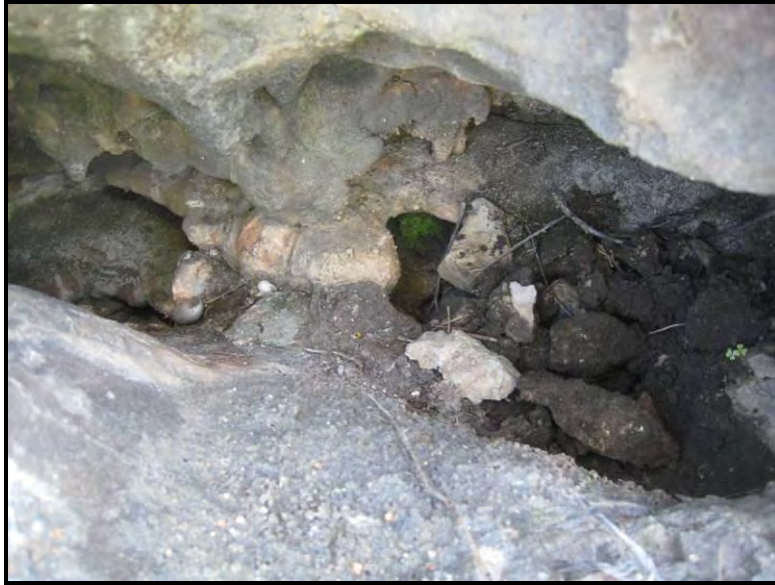
Figure 134. Interior of feature 281-077.

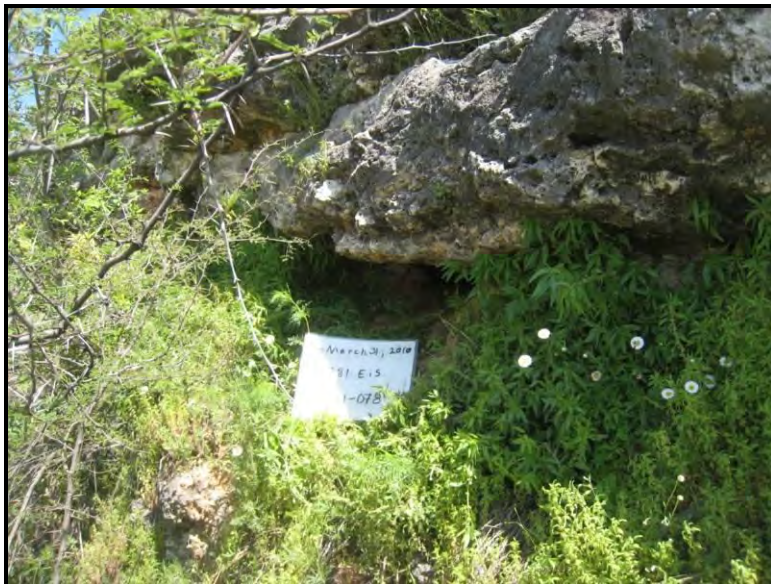
Figure 135. Overview of feature 281-078.

281-078, solution cavity/animal burrow This feature is located in the east road cut of US 281. It is an enlarged bedding plane with an entrance that is 0.4 m (1.3 ft) wide and 0.2 m (0.7 ft) high. It extends at least 1.5 m (4.9 ft) into the road cut with a continuing void, and has slight airflow (Figure 135). It was excavated on 21 June 2010. Utilizing 6 person-hours of labor, 1 m³ (35 ft³) of material was removed; no continuing voids were seen (Figure 136). Post-excavation dimensions of the feature were 1.5 m (4.9 ft) long by 1 m (3.3 ft) wide by 0.5 m (1.6 ft) deep. The only fauna observed in this feature were two centipedes, one in the order Geophilomorpha and the other in the order Lithobiomorpha (family Lithobiidae). This feature appears to be an animal burrow.

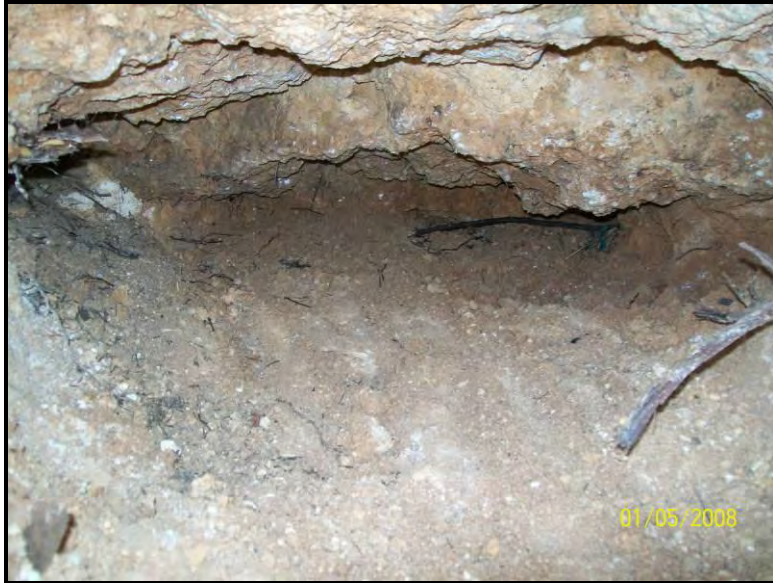
Figure 136. Interior of feature 281-078 after excavation.

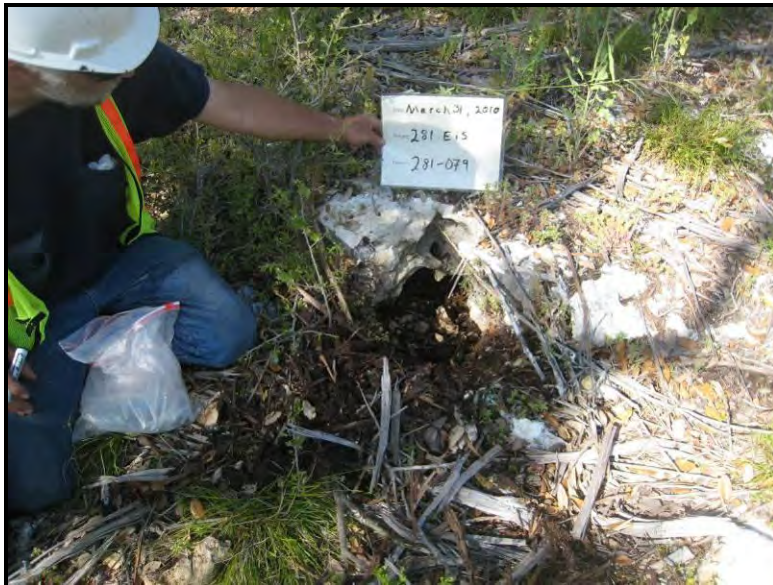
Figure 137. Overview of feature 281-079.

281-079, animal burrow This feature is located on private property on the east side of US 281. The entrance is 0.4 m (1.3 ft) wide, 0.3 m (1 ft) tall, and it extends in for at least 0.5 m (1.6 ft) (Figure 137). It appears to be epikarstic void that was enlarged by animal burrowing (Figure 138). This feature was not recommended for excavation (Table 1).

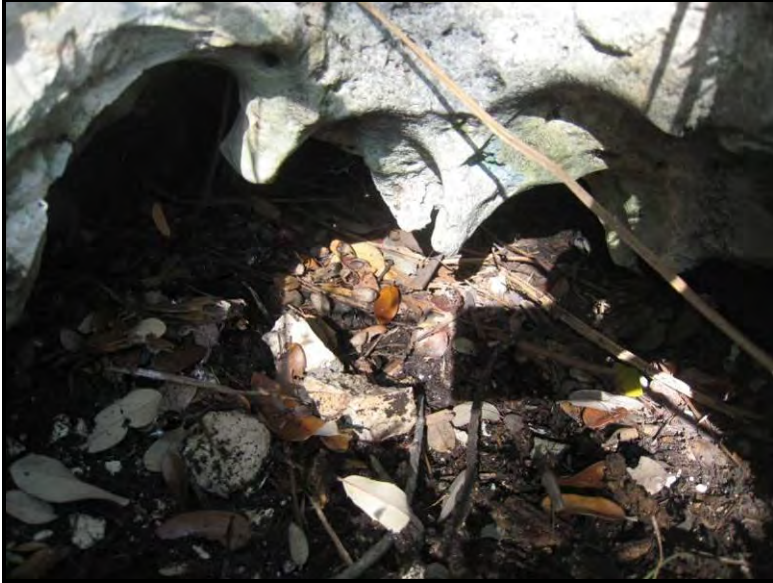
Figure 138. Interior of feature 281-079.

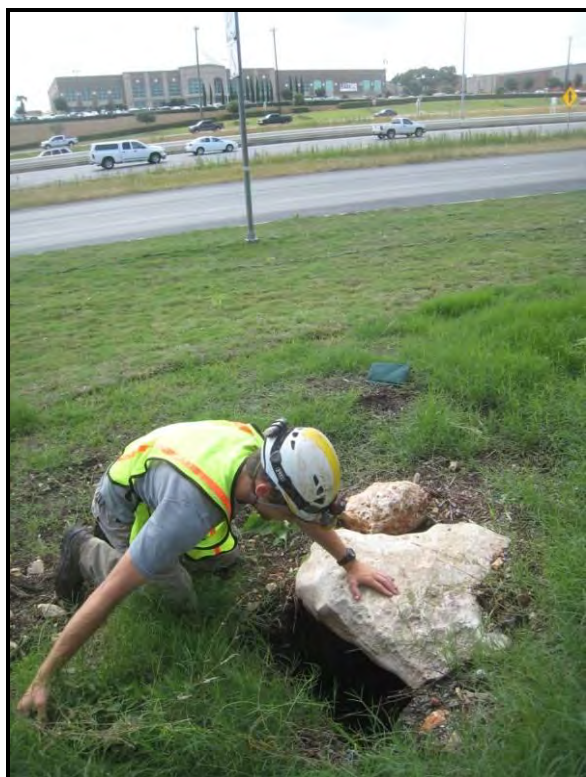
Figure 139. The entrance to Power Pole Hole had a rock partially covering it when initially assessed.

281-080, Power Pole Hole, cave This cave is located on the west side of US 281, to the south of Sonterra Boulevard. It is just inside the ROW, about 8 m (26.2 m) from the edge of pavement of the US 281 feeder road (Figure 139). This is a cave that was apparently intersected by power pole drilling installation operations sometime in the past. Although this feature was partially open when initially assessed, excavation was needed to remove fill material that had been dumped in, in order to access karst invertebrate habitat for sampling. A large quantity of recycled asphalt had been dumped into the cave in an apparent effort to plug the cave. Excavations were conducted on 20 May, 11, 12, 17, and 29 June, 19, 20, and 26 August, and 10 and 17 September 2010. A total of 8.16 m³ (288 ft³) of material was removed from the feature using 97.8 person-hours of effort.

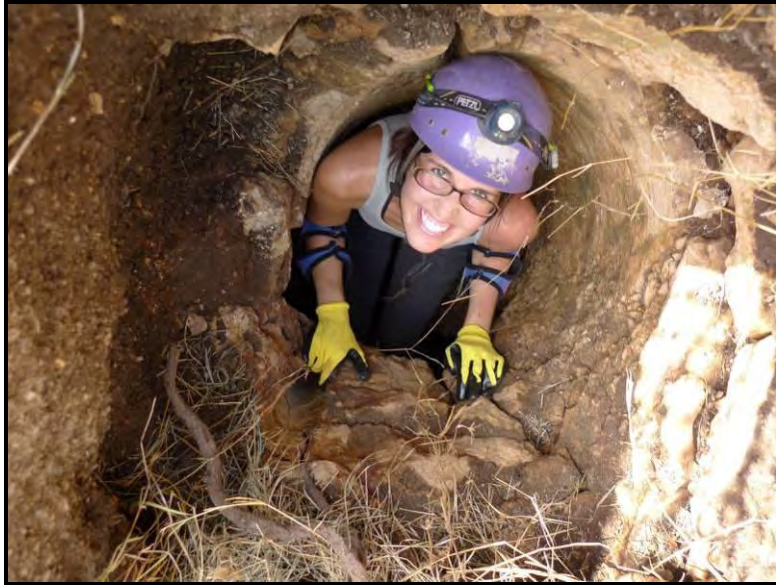
Figure 140. The circular drilling pattern can be seen in this image of the Power Pole Hole entrance.

The entrance to Power Pole Hole is 0.8 m (2.6 ft) in diameter and was covered with a limestone slab when initially encountered. The entrance appears to be a drilled hole created to anchor a power pole (Figure 140). The pole was installed in a new foundation 1 m (3.3 ft) to the southwest, presumably after the drillers realized that they had hit a void. Judging by fill-plugged in-feeders just below the surface, this cave may have had a natural entrance (or associated karst feature) in the ROW just to the east that was graded over during highway construction. When initially assessed, the cave consisted of a 3 m (9.8 ft) climb-down to a plugged floor. Fill material sloped down to the south end where two copper ground rods penetrated the ceiling from the power pole above (Figure 141). Excavation efforts concentrated on removing asphalt fill and opening up apparent passages extending off to the north and south. The northern crawlway went for 3 m (9.8 ft) to a terminus. The southern crawlway went down the slope past the ground rods, and then sloped upward in a low section that opened up into a spacious chamber (Figure 142). This chamber is about 7 m (23 ft) across and up to 4.5 m (14.8 ft) in height. Flowstone and stalactites cover parts of the ceiling, walls, and floor (Figure 143). Most of the floor consists of silt. Mesocavernous voids extend off of the western portion of the room at different points of the walls and ceiling. Post-excavation dimensions of this feature were 13 m (42.7 ft) long by 5 m (16.4 ft) wide by 1 m (3.3 ft) deep.

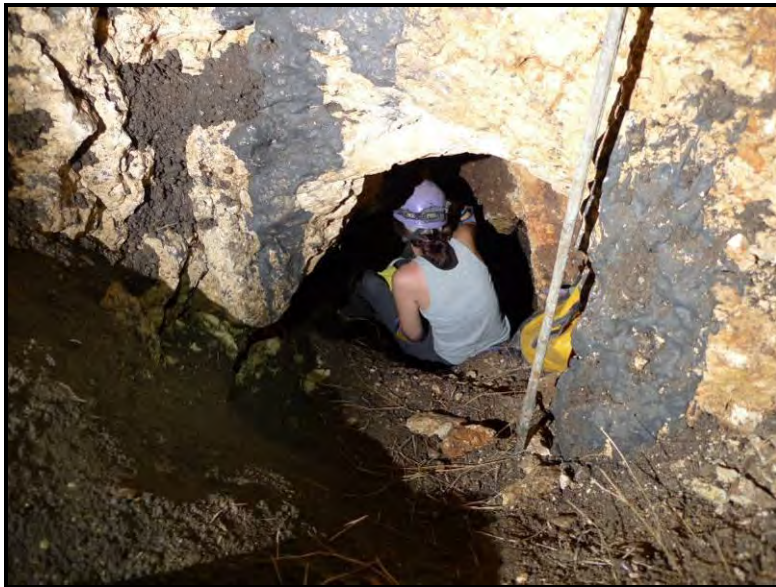
Figure 141. A copper power pole ground rod pierces the ceiling at the entrance to the South Crawl in Power Pole Hole. A tar-like substance covers portions of the walls, apparently associated with the pole installation.

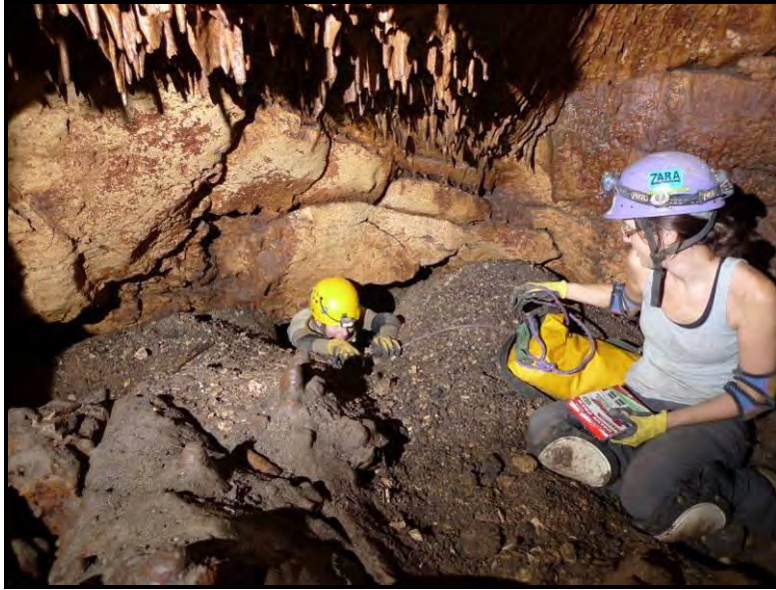
Figure 142. The South Crawl goes up a slope to emerge into the South Chamber in Power Pole Hole.

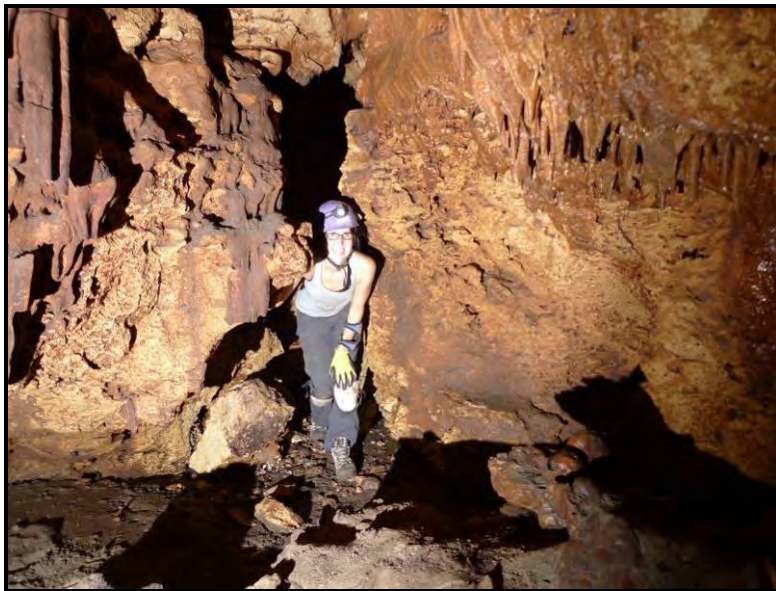
Figure 143. The South Chamber walls are partially covered in flowstone.

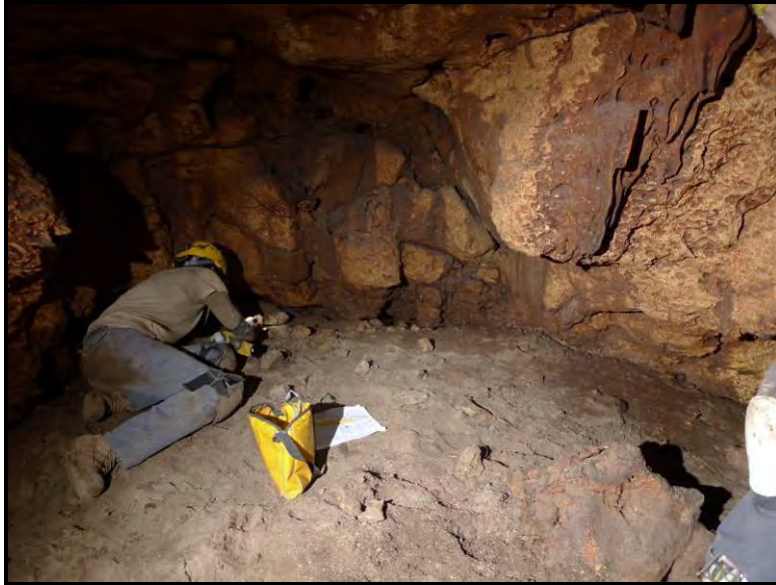
Figure 144. A biologist inspects the silt-covered floor of the South Chamber.

Biological surveys on this feature were conducted on 16 and 24 September and 1 October 2010 (Figure 144). A complete list of fauna encountered in 281-080 is included as Table 23, and microclimate measurements are included as Table 24. A map of Power Pole Hole is presented in Figure 145.

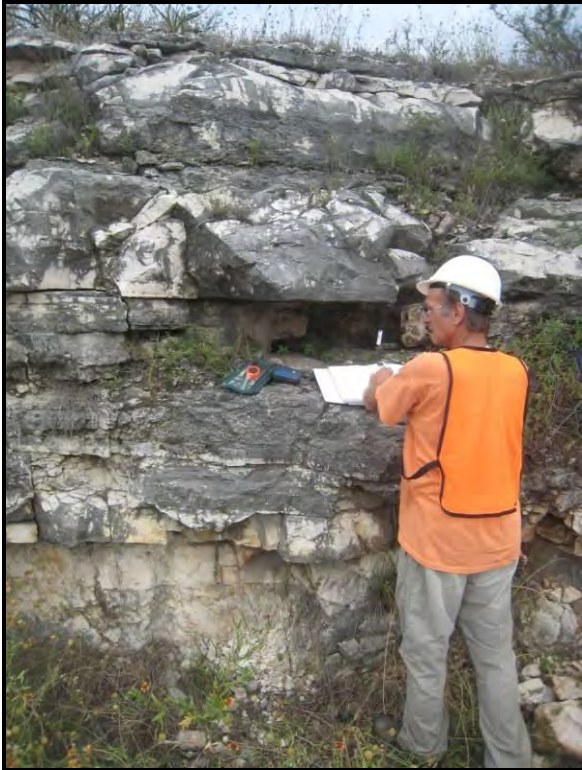
Figure 146. Overview of feature 281-081.

281-081, solution cavity/enlarged bedding plane This feature is located in the west road cut of US 281. It is an enlarged bedding plane with an entrance that is 1.5 m (4.9 ft) wide and 0.3 m (1 ft) high (Figure 146). It can be seen to extend into the road cut for at least 1.25 m (4.1 ft). This passage is initially 0.4 m (1.3 ft) wide, and splits into two branches which become smaller (Figure 147). The right hand branch contains some concrete in it of unknown origin. This concrete may have flowed out of this branch when some feature was plugged above it. Aside from the concrete, this feature has no infill material. Visible surfaces are covered with calcite. This feature was not recommended for excavation (Table 1).

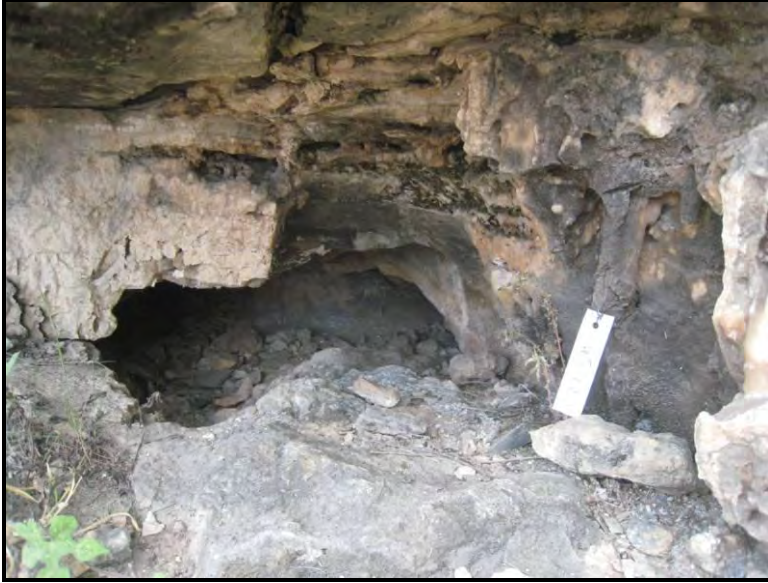
Figure 147. Interior of feature 281-081. Concrete can be seen on the right rear side.

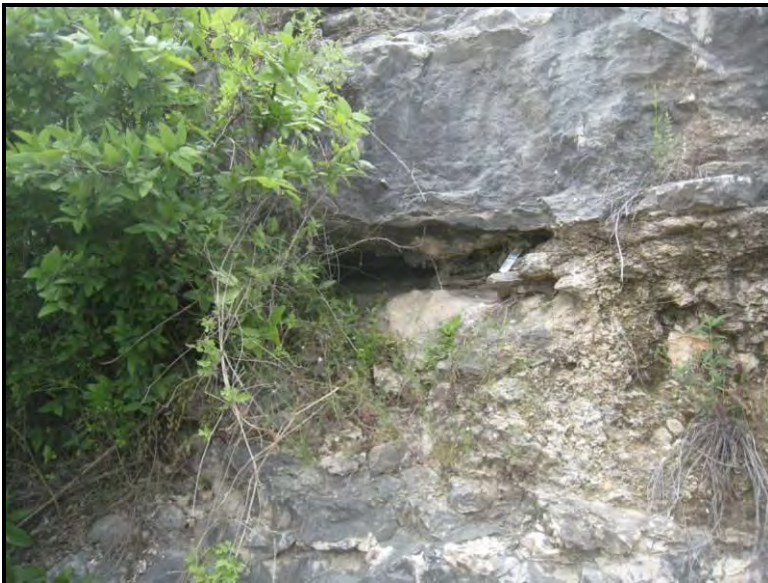
Figure 148. Overview of feature 281-082.

281-082, solution cavity/enlarged bedding plane This feature is located in the west road cut of US 281. It is an enlarged bedding plane with an entrance that is 3 m (9.8 ft) wide and 0.5 m (1.6 ft) high (Figure 148). It extends into the road cut for 1 m (3.3 ft), and has no voids extending off of it. It contains no infill material and exhibits no evidence of moisture or speleothems (Figure 149). This feature was not recommended for excavation (Table 1).

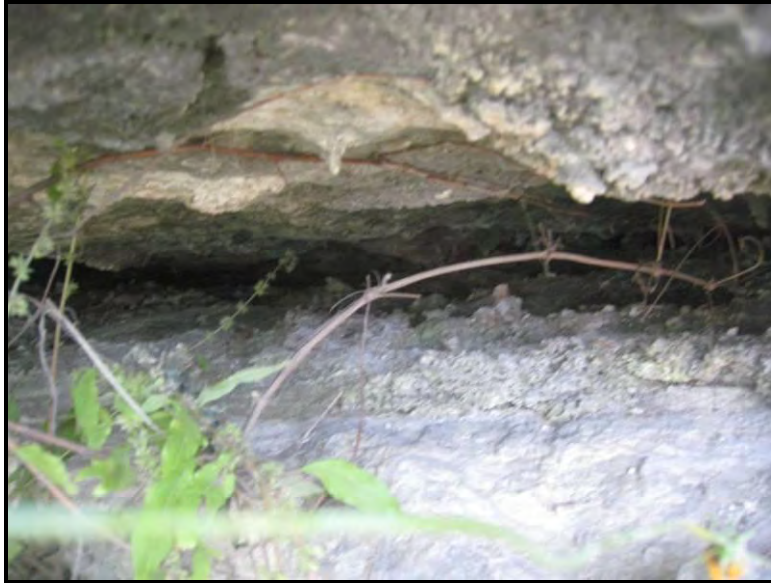
Figure 149. Interior of feature 281-082.

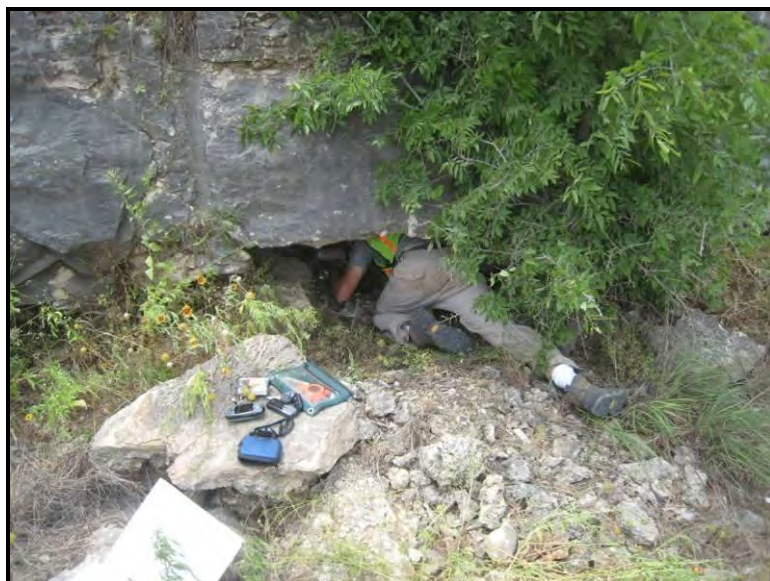
Figure 150. Exterior of feature 281-083.

281-083, Dripstone Cave This cave is located in the western road cut of US 281, to the south Marshall Road. It is formed in an enlarged bedding plane. Two entrances 3 m (9.8 ft) apart join up as a wide, low bedding plane void that was likely formed under phreatic⁵ conditions (Figure 150). The cave is 13 m (42.7 ft) long by 5 m (16.4 ft) wide by 1 m (3.3 ft) deep. This cave is located at the very base of the road cut, and receives channelized recharge from the bar ditch. The entrance had been previously excavated. The walls and ceiling of this cave are mostly covered in calcite, which gave rise to the name Dripstone Cave (Figure 151). The floor is covered in loose, calcite-encrusted rocks. There is little organic debris, apart from some mammal scat. Several small voids extend off of the back of the cave (Figure 152). Biological surveys on this feature were conducted on 14, 21, and 29 June and 9 and 16 September 2010. A complete list of fauna encountered in 281-083 is included as Table 25.

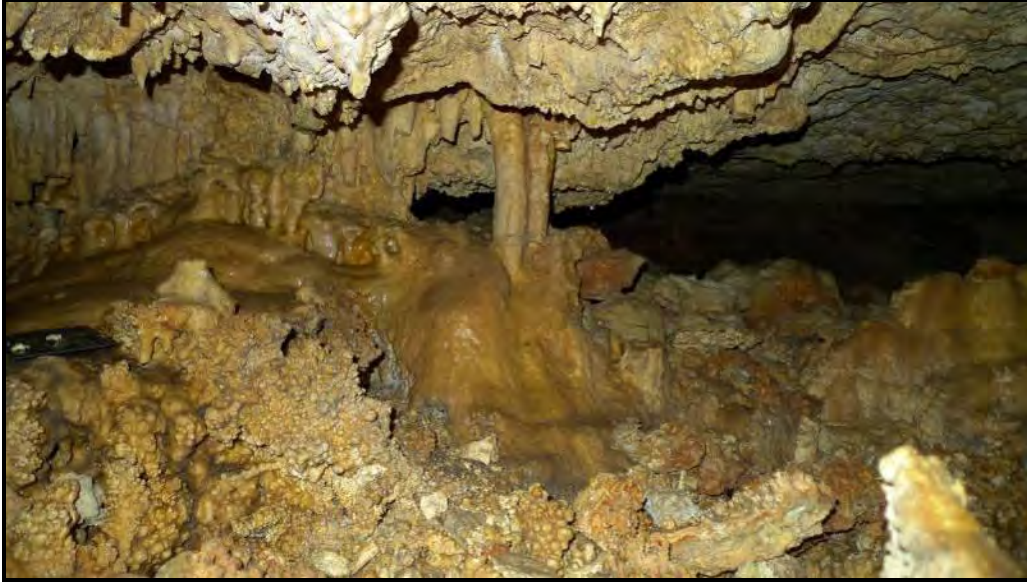
Figure 151. Interior of feature 281-083, with baited glue trap on left.

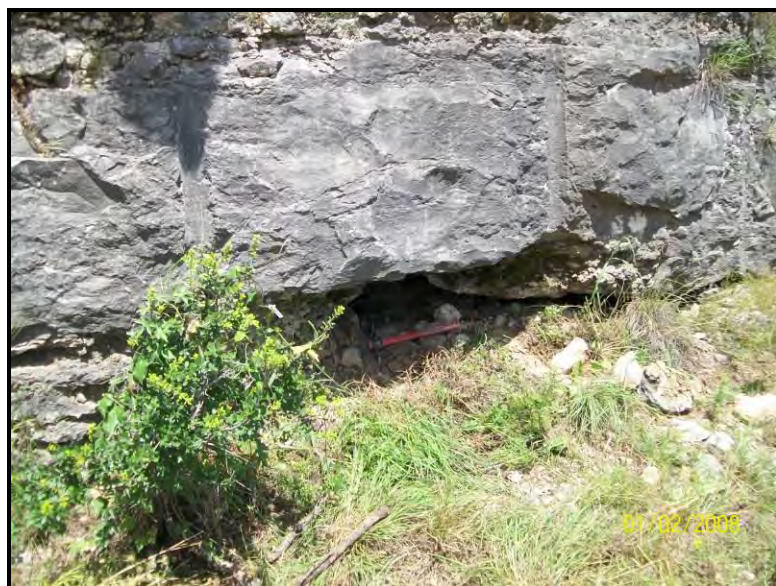
Figure 153. Overview of feature 281-084 prior to excavation.

281-084, solution cavity/enlarged bedding plane This feature is located on the west side road cut of US 281, to the south of Marshall Road. It is formed in an enlarged bedding plane. When initially assessed the entrance was 1.3 m (4.3 ft) wide and 0.35 m (1.1 ft) high, and it extended over 1.5 m (4.9 ft) into the road cut (Figure 153). The passage made an 80 degree turn to the right beyond which it could not be examined, and thus was considered to be potentially humanly enterable. It was excavated on 18 June 2010. Using hand tools, 1.25 m³ (44 ft³) of material was removed with 9.5 person hours of effort. This enlarged the feature to 3 m (9.8 ft) in width 1.25 m (4.1 ft) in height, and it extended just over 2 m (6.6 ft) into the road cut. No continuing voids existed (Figure 154). Fauna encountered in feature 281-084 are included in Table 27.

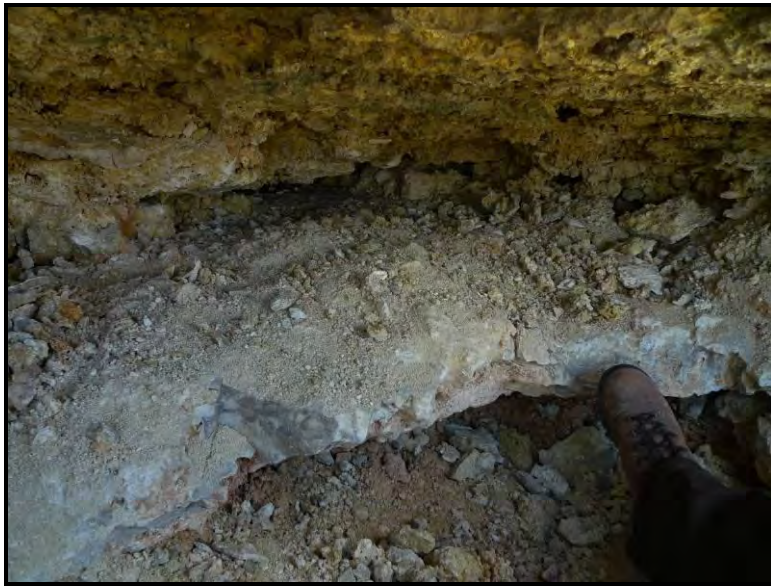
Figure 154. Interior of feature 281-084 after excavation.

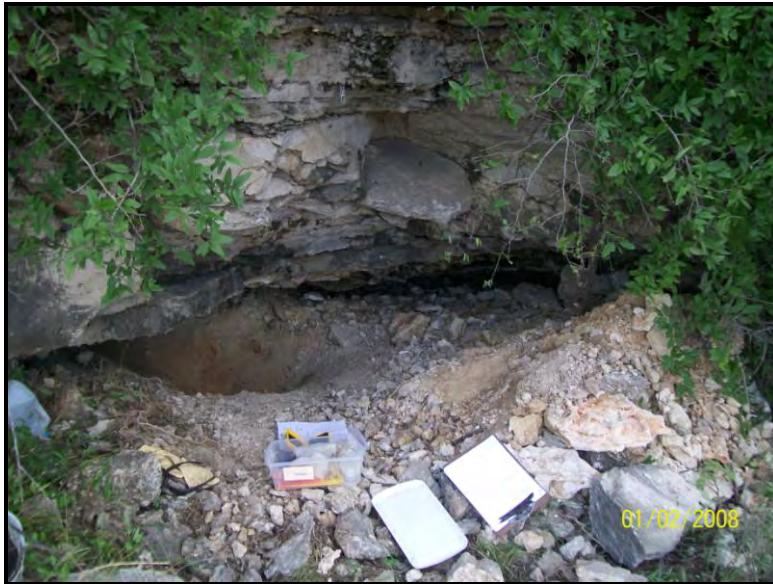
Figure 155. Overview of feature 281-085.

281-085, solution cavity/enlarged bedding plane This feature is located in the western road cut of US 281, to the south Marshall Road. It is formed in an enlarged bedding plane at the base of the road cut, and it takes channelized drainage from the bar ditch (Figure 155). The entrance is 4 m (13.1 ft) wide and 2 m (6.6 ft) tall. When initially assessed it quickly became too low to enter, but extended at least 3 m (9.8 ft) into the road cut and was considered to be potentially humanly-enterable. Excavation was conducted on 18 June 2010 for 6 person hours, removing 0.75 m³ (26.5 ft³) of material from the feature. The floor was lowered, enabling the back of the feature to be examined. Post-excavation dimensions of the feature were 4 m (13.1 ft) in width and 2.5 m (8.2 ft) in height and extended 3 m (9.8 ft) into the road cut. No voids continued on (Figure 156), but the detection of troglobitic species during excavation prompted the initiation of presence/absence surveys. Biological surveys on this feature were conducted on 25 June and 1, 9, and 16 September 2010. A complete list of fauna encountered in 281-085 is included as Table 28.

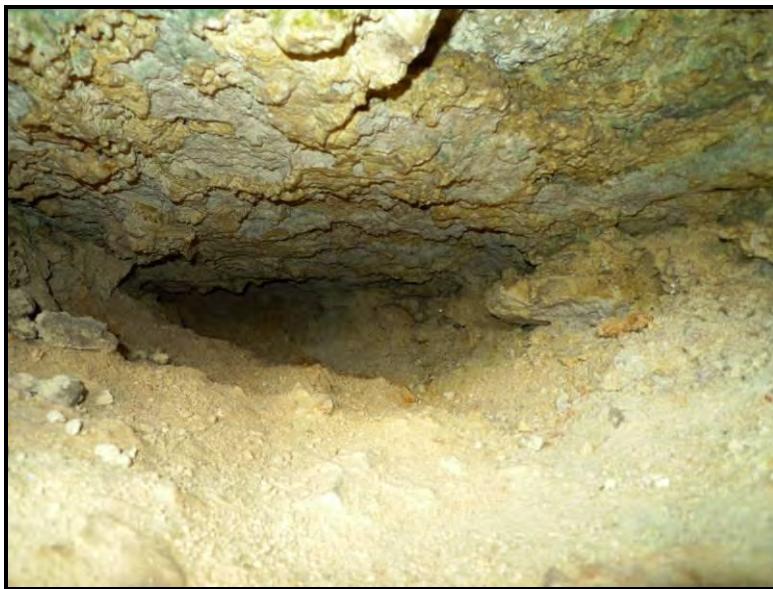
Figure 156. Interior of feature 281-085 after excavation.

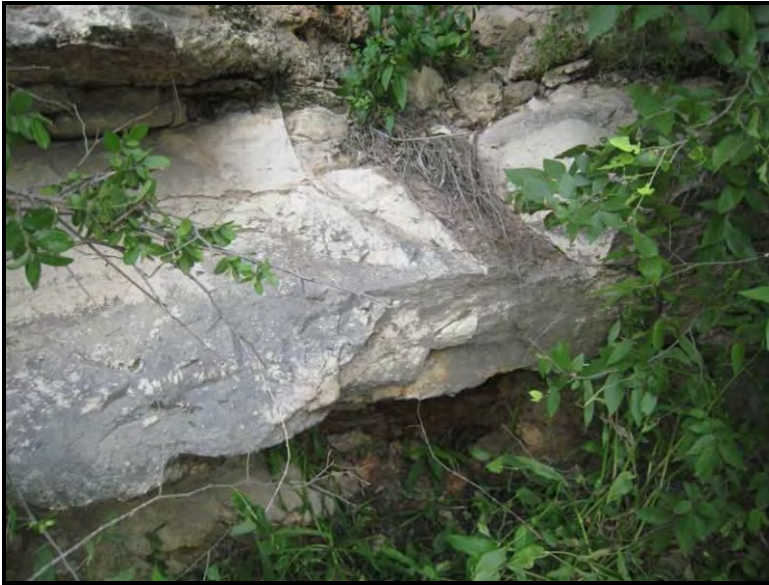
Figure 157. Exterior of feature 281-086.

281-086, solution cavity/enlarged bedding plane This feature is located in the western road cut of US 281, to the south Marshall Road. It is formed in an enlarged bedding plane. The entrance is 2 m (6.6 ft) wide and 0.45 m (1.5 ft) high (Figure 157). It extends 1 m (3.3 ft) into the road cut, at which point a small portal that is not humanly-enterable continues for an unknown distance (Figure 158). It is formed at the base of the road cut, taking channelized drainage from the bar ditch. Previous excavation has occurred here, as evidenced by a tailings pile just outside of the entrance. This feature was not recommended for additional excavation (Table 1).

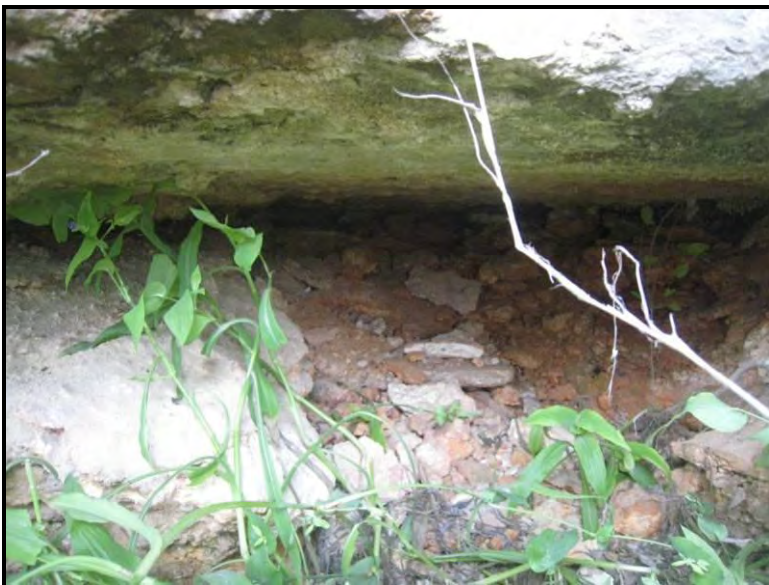
Figure 158. Interior of feature 281-086.

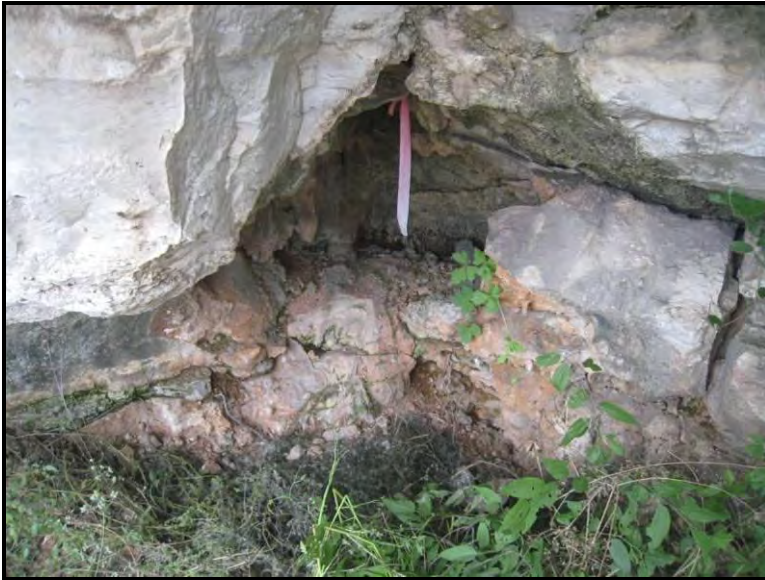
Figure 159. Overview of feature 281-087.

281-087, solution cavity/enlarged bedding plane This feature is located in the western side road cut of US 281, to the south Marshall Road. It is formed in an enlarged bedding plane. The entrance is 3 m (9.8 ft) wide and 1.5 m (4.9 ft) high (Figure 159). It extends 1.5 m (4.9 ft) into the road cut. There is no soil infill, and some of the surfaces are covered in

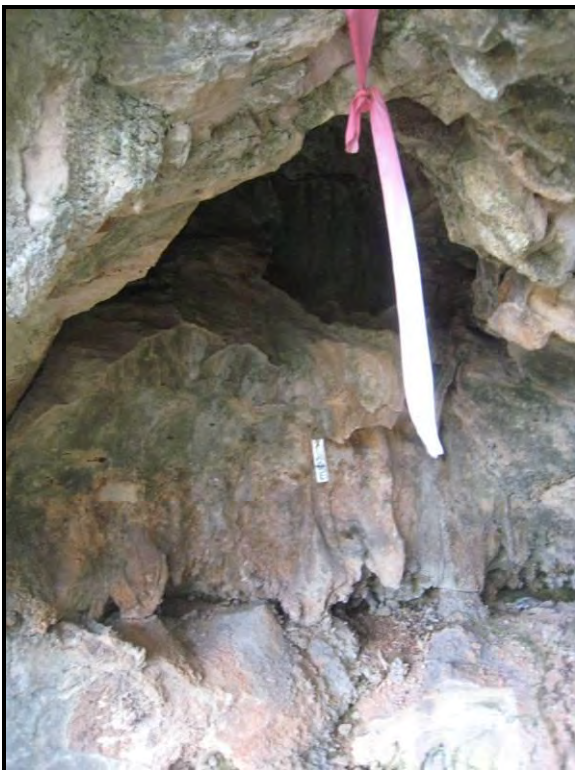
Figure 160. Interior of feature 281-087.

calcite. There are no mesocavernous voids extending from the feature (Figure 160). This feature was not recommended for excavation (Table 1).

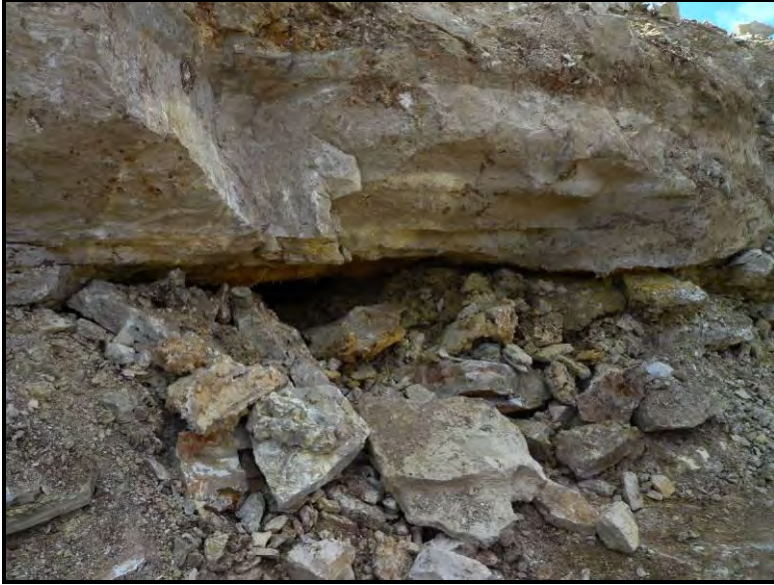
Figure 161. Entrance to feature 281-088 prior to excavation.

281-088, Zombie Cave This feature was revealed by roadway widening construction in June 2010 (Figure 161). The entrance was 3 m (9.8 ft) wide, 0.5 m (1.6 ft) tall, and it could be seen to extend into the road cut for at least 4 m (13.1 ft). It was excavated on 23 and 26 August. Excavation removed rocks from the floor to enable access to the interior of the cave (Figure 162). Features 281-089 and 281-091, which are adjacent to the south, were

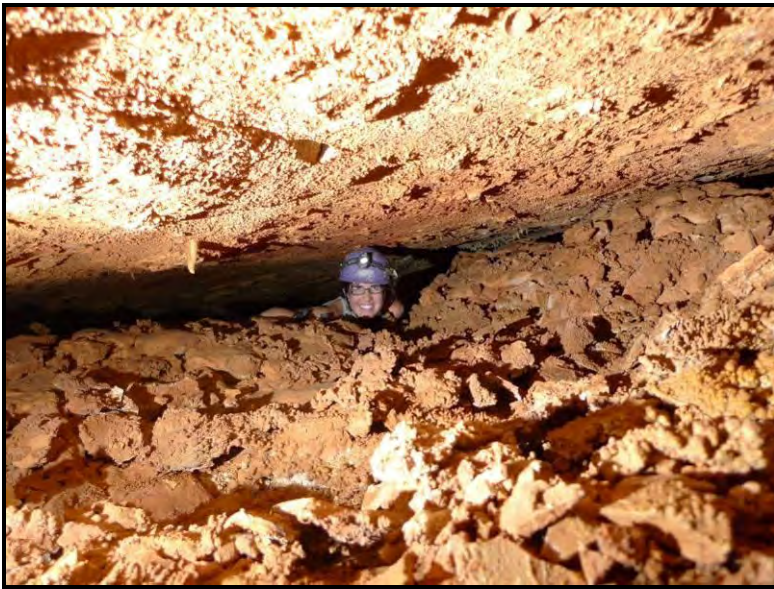
Figure 162. Interior of feature 281-088.

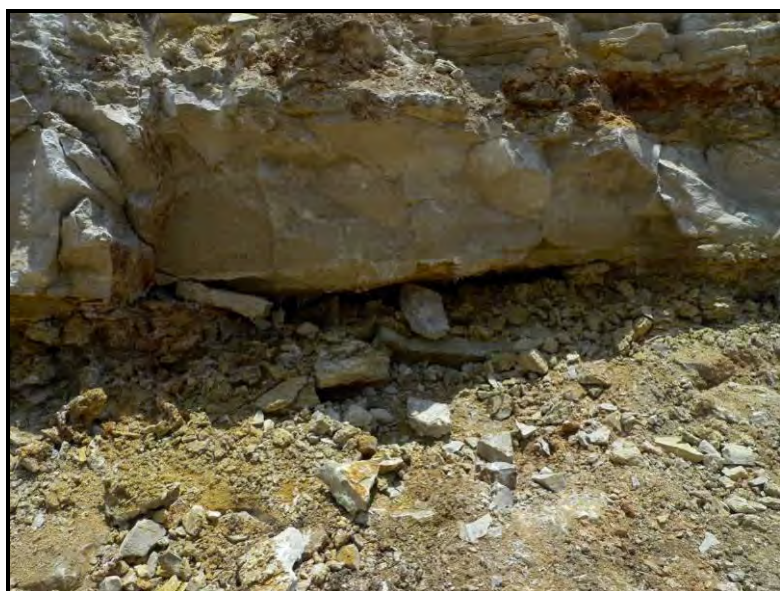
Figure 164. Entrance to feature 281-089 prior to excavation.

281-089, Zombie Cave This karst feature is located in the road cut just south of Zombie Cave, and upon excavation and investigation was found to connect to it (Figure 164). See the description of 281-088 for more information.

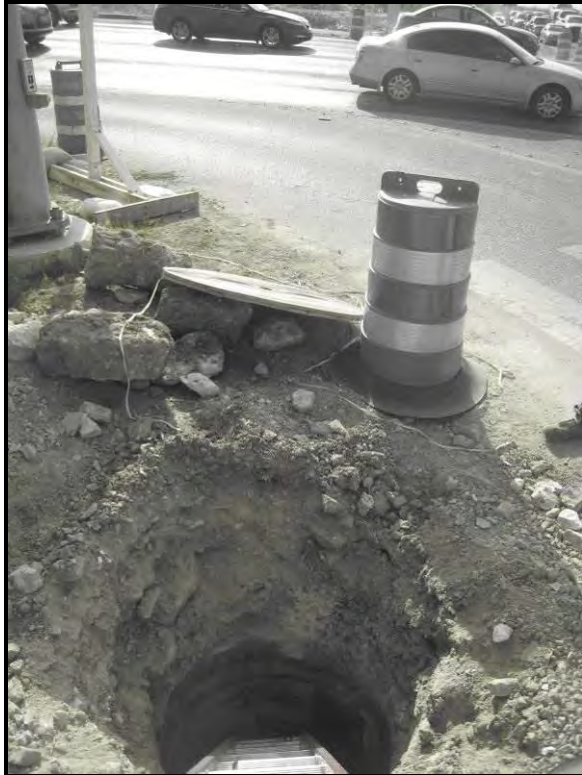
Figure 165. Overview of feature 281-090.

281-090, solution cavity In August 2010 a construction team working on the installation of a traffic signal at the intersection of Evans Road and 281 encountered a karst feature while drilling a 1 m (3.3 ft) diameter foundation (Figure 165). Excavations were conducted on 25 and 26 August 2010 to remove drilling rubble in order to assess the void for karst invertebrate habitat (Figure 166). The drilled shaft was 3 m (9.8 ft) deep, with the void extending off of the north wall. The opening into the void extended from the floor of the shaft at -3 m (-9.8 ft) to a point 1.6 m (5.2 ft) above that. The total vertical extent of the void was 3 m (9.8 ft), with tiny voids extending off of the top and bottom of it. Post-excavation dimensions of the feature were 2 m (6.6 ft) long by 2.5 m (8.2 ft) wide and 3 m (9.8 ft) deep. Most of the surfaces within the void were encrusted with calcite, including the floor drain which effectively plugged it (Figure 167). Although the feature did not necessarily meet all of the guidelines presented in USFWS (2006) for warranting excavation or subsequent presence/absence surveys, a troglobitic species (*Texoreddellia* sp.) was encountered during excavation, prompting the initiation of presence/absence surveys, which were carried out on 1, 9, and 16 September 2010. A complete list of fauna encountered in 281-090 is included in Table 32. A map is presented in Figure 168.

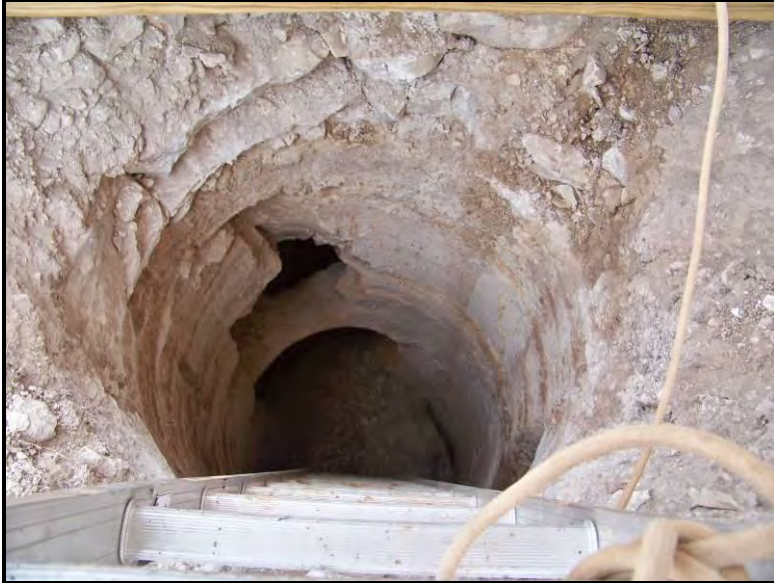
Figure 166. View down drilled shaft at feature 281-090 after excavation.

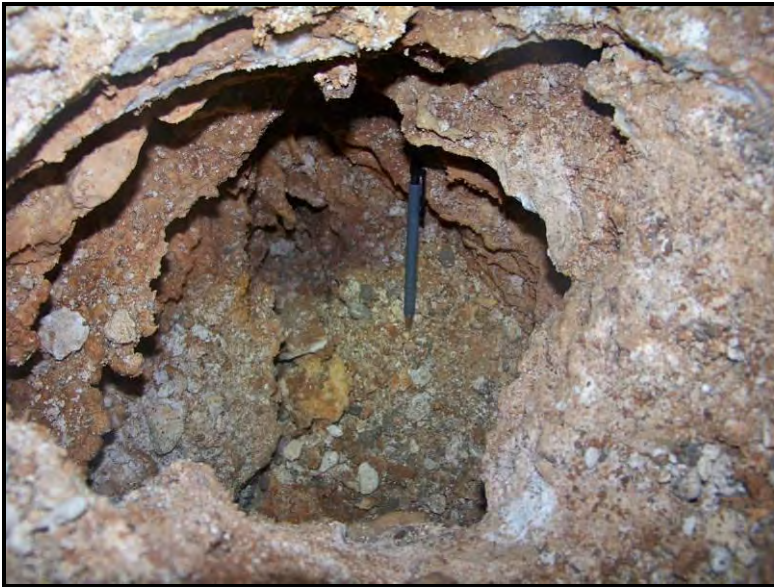
Figure 167. View of calcite-plugged drain in feature 281-090.

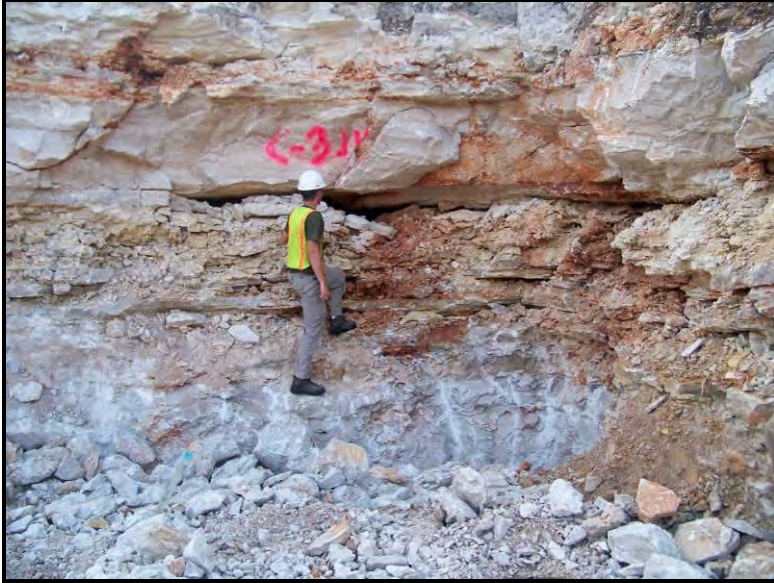
281-091, Zombie Cave This is another feature located in the road cut south of Zombie Cave (Figure 169). This feature was exposed during road widening activities in August 2010. Excavation conducted at that time resulted in its connection to Zombie Cave. See the description of 281-088 for more information.

Figure 169. Overview of feature 281-091 prior to excavation.

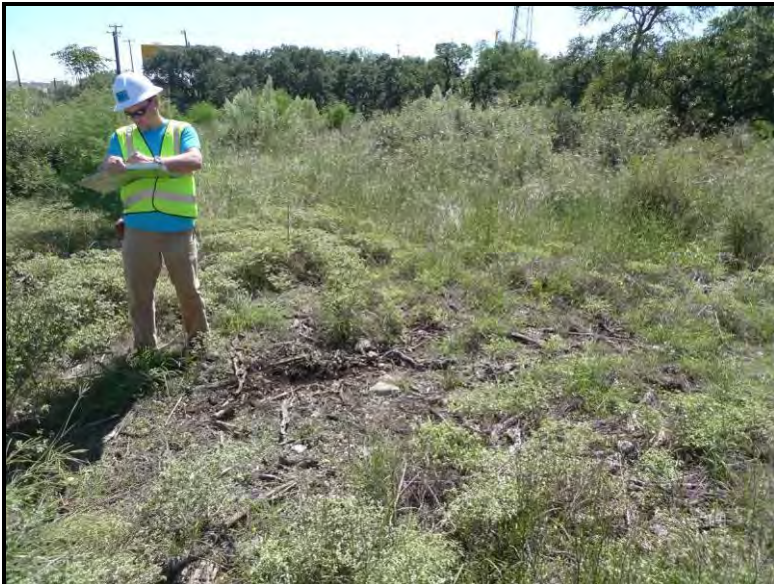
281-094, non-karst closed depression This is a shallow depression that is 4 m (13.1 ft) long, 1.5 m (4.9 ft) wide, and 0.3 m (1 ft) deep. It has a hard-packed clay floor, with no drains (Figure 170). It is likely the result of land clearing operations. This feature was not recommended for excavation (Table 1).

Figure 170. Overview of feature 281-094.

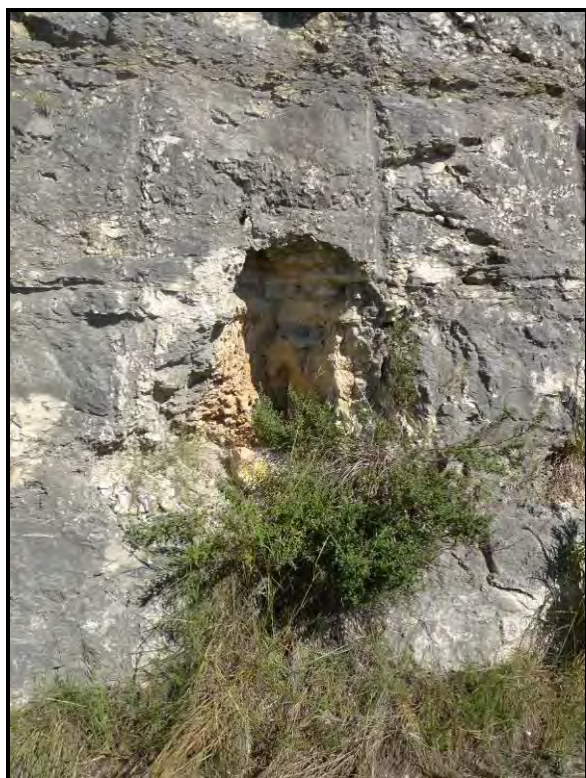
281-095, solution cavity This solution cavity is located in the eastern road cut of US 281. When initially assessed, it was 1 m (3.3 ft) wide, 1.3 m (4.3 ft) tall, and it extended into the road cut for 0.5 m (1.6 ft) (Figure 171). It contained some gravel infill that may be associated with construction excavation activities. The walls were partially covered with calcite. It is developed along a fracture trending at approximately 133 degrees. It was excavated on 1 October 2010. This effort removed 1 m³ (35 ft³) of material utilizing 6 person hours of labor. The feature was enlarged along the fracture to yield post-excavation dimensions of 1 m (3.3 ft) wide by 2 m (6.6 ft) tall, and it extended 1 m (3.3 ft) into the road cut (Figure 172). The fracture narrowed nearly to closure, with no airflow. A list of fauna encountered in feature 281-095 is included as Table 34.

Figure 171. Overview of feature 281-095.

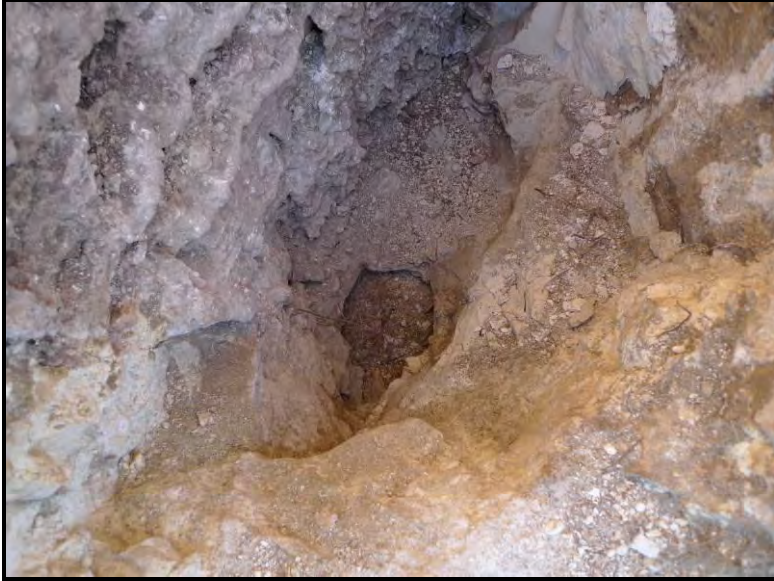
Figure 172. Interior of feature 281-095 after excavation.
